TEST REPORT

REPORT NO.: J20111270840

Product : **POLE CONE**

Description of sample : Brand : JISLON
Model : NS Type
Material : Polyurethane Plastics
Quantity : 2 pieces of test samples were submitted for testing.

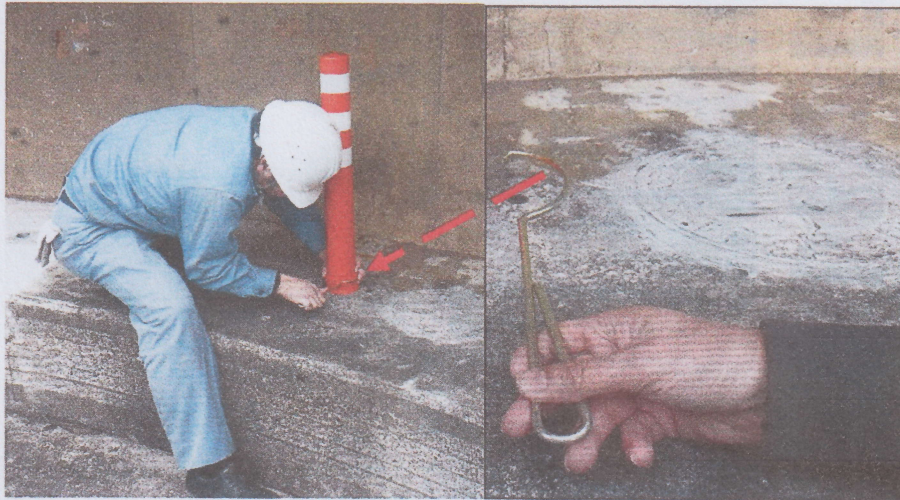
Photo 1: Pole cone must be fastened completely with the torque 106 N.m using special installation tool (SJC tool)

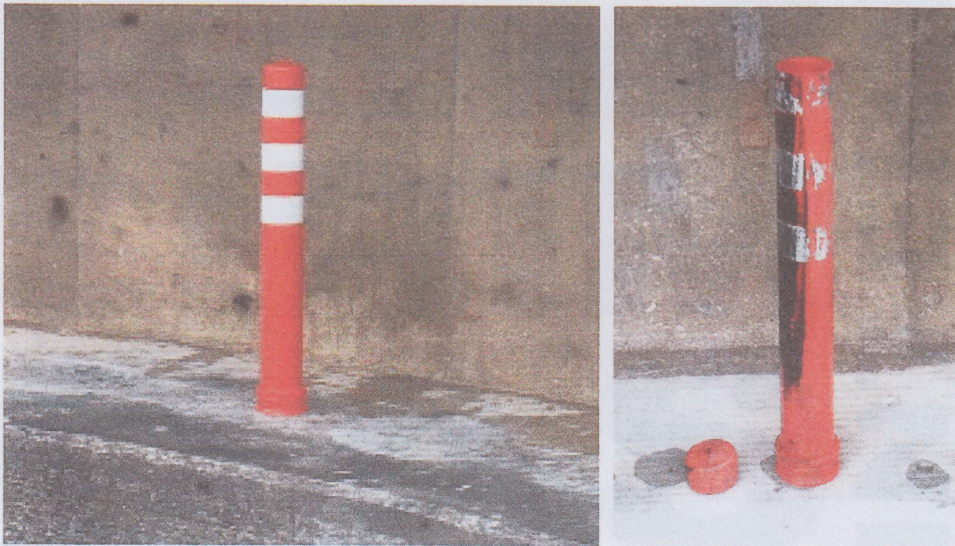
Photo 8 and 9: Photograph before and after.
The top of pole cone without extrusion pipe was broken at 140 impacts.

Sample: Pole Cone NS Type	Durability of Impacts	Speed Recorded (km/hour)*	Portion of tested sample			Observation / Remark
			Base	Body	Top (cap)	
Extrusion pipe	1000	i. 69.3 ii. 69.7 iii. 70.2	OK	OK	558 Impact (dislodged)**	No dislodged and damaged after being subjected of Resistance to Impact test.
Without extrusion pipe	1000	69.7 km/hour (Average)	OK	OK	140 Impact (dislodged)**	No dislodged and damaged after being subjected of Resistance to Impact test.

**The top (cap of pole cone) is not part of design concept by Sekissui Jushi Corporation and its stiffness in the upper part of the cone but remains functional.
