RAYSPEED HOLDING SDN BHD

JISLON FLEXIBLE POST

TEST REPORT

REPORT NO. J20111270840 PAGE: 1 OF 7

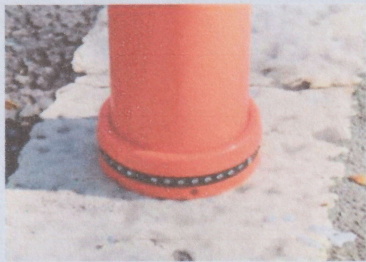
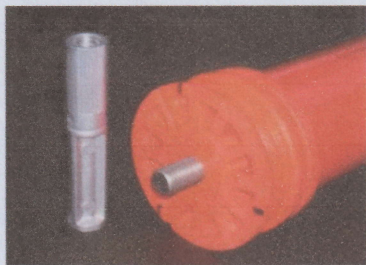
With inner pipe for added strength

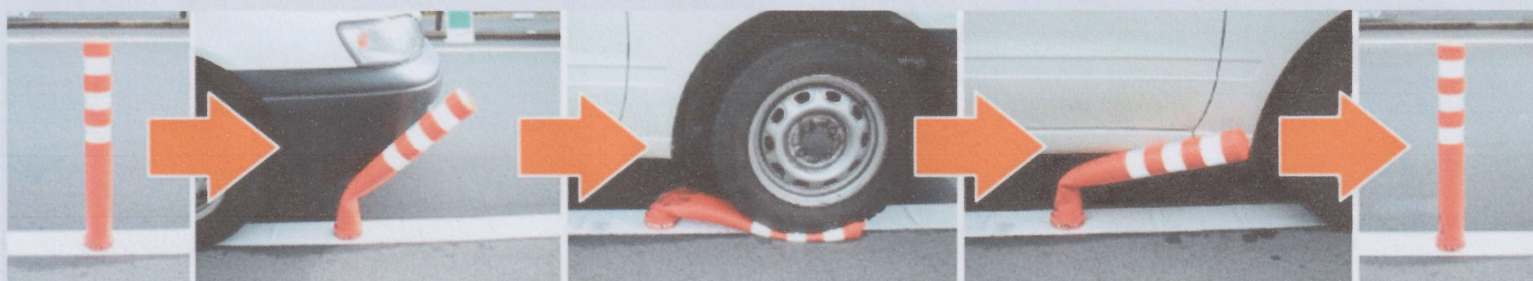
Rebound Performance

❑ **Test condition:**

Speed: 70km/h
 Load: 800kg
 Frequency: 1000 times

❑ **Result:**

After 1000 hits, the flexible post rebound to original position.

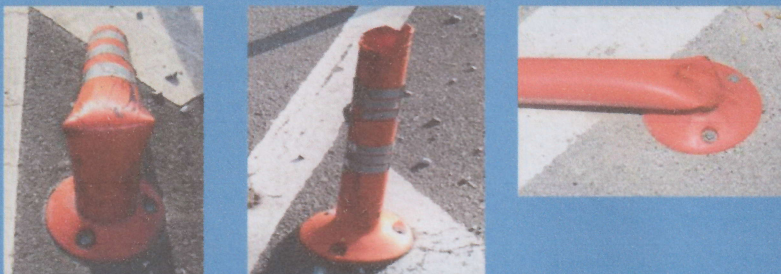
Three screw can easily dislodge with impact, stump and screws remain on the road

Single embedded anchor in the middle

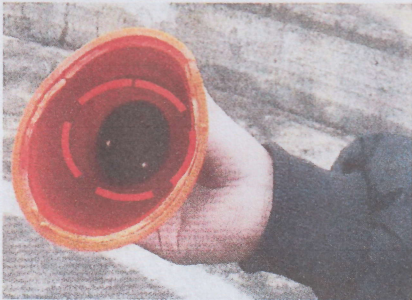
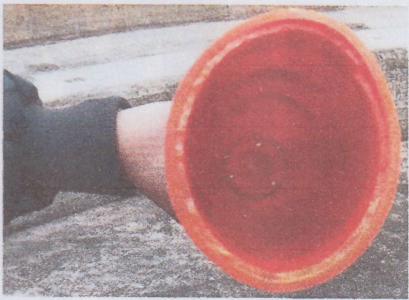
| Sample Identification | <div style="display: flex; justify-content: space-around; align-items: center;"> <div style="text-align: center;"> <p>Pole Cone with extrusion pipe</p> </div> <div style="text-align: center;"> <p>Pole Cone without extrusion pipe</p> </div> </div> |

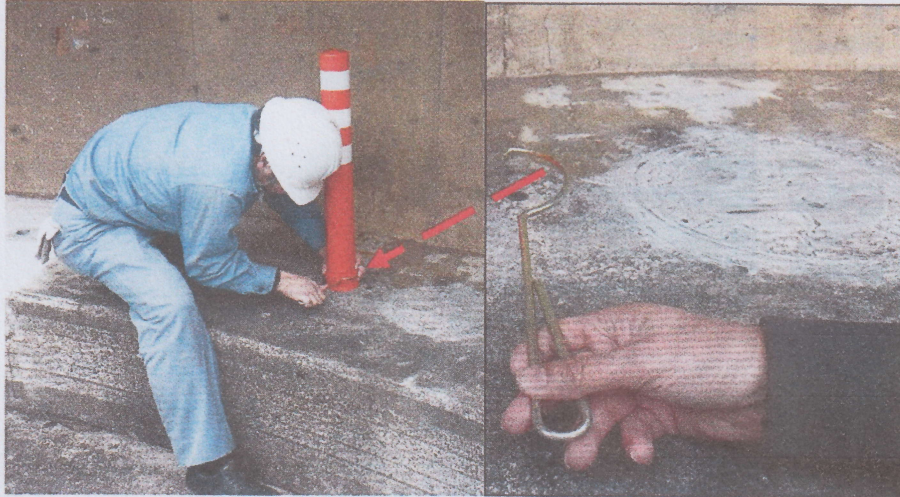
Photo 1: Pole cone must be fastened completely with the torque 106 N.m using special installation tool (SJC tool)

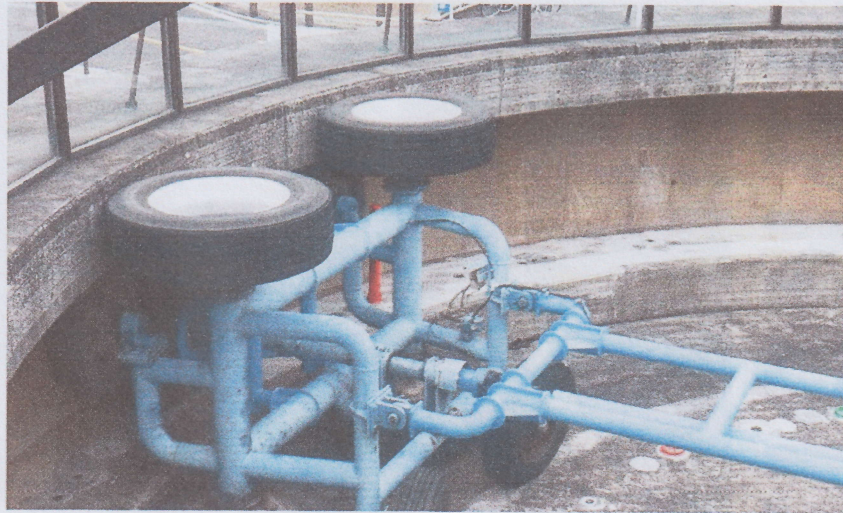
Photo 3: Test condition – Pole cone during impact testing

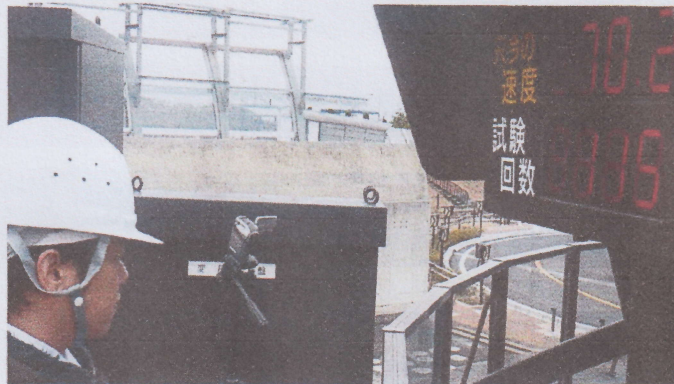
Photo 4: The monitor shows the speed of 70.2 km/hour

| Sample: Pole Cone NS Type | Durability of Impacts | Speed Recorded (km/hour)* | Portion of tested sample | | | Observation / Remark |
|---|---|---|---|---|---|--|
| Extrusion pipe | 1000 | i. 69.3 ii. 69.7 iii. 70.2 | OK | OK | 558 Impact (dislodged)** | No dislodged and damaged after being subjected of Resistance to Impact test. |

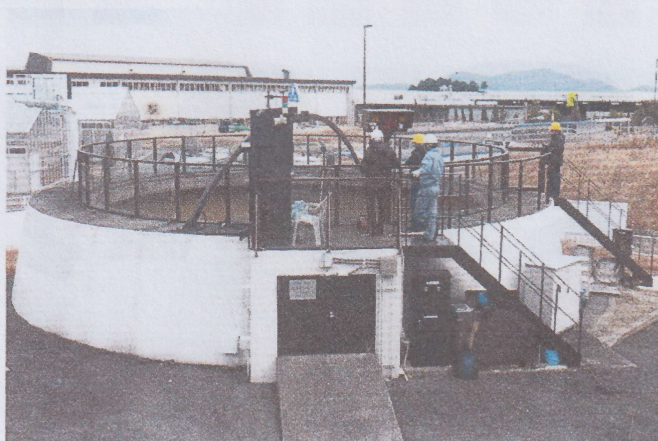
Photo 5: The Flying Wheel Tester Machine in Siga Plant, Ryuo factory.

| Test Machine | Flying Wheel Testing Machine |
| Place | Siga Plant, Ryuo factory |

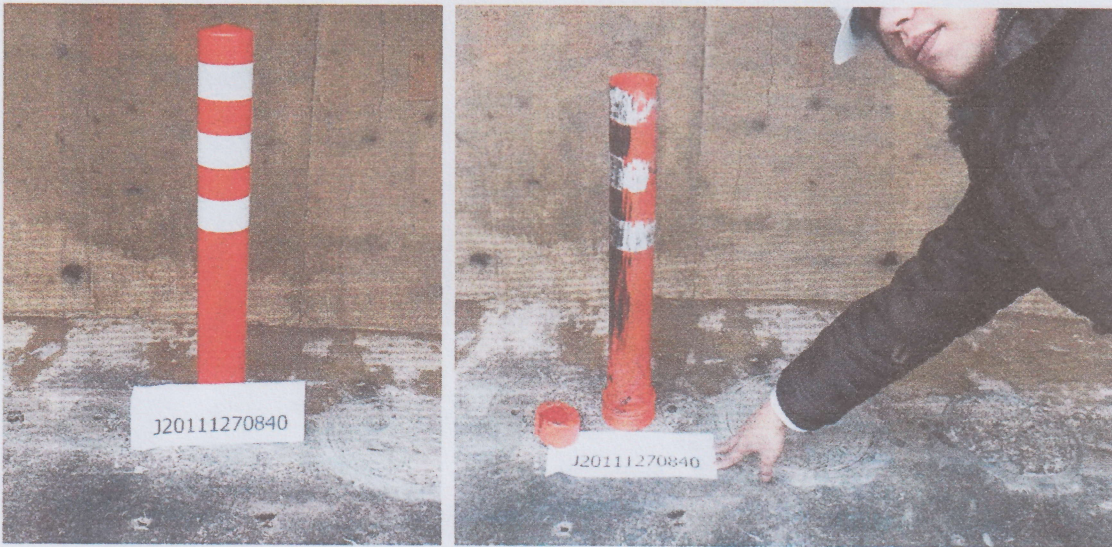
Photo 6 and 7: Photograph before and after.
The top of pole cone with extrusion pipe was broken at 588 impacts.

**The top (cap of pole cone) is not part of design concept by Sekissui Jushi Corporation and its stiffness in the upper part of the cone but remains functional.

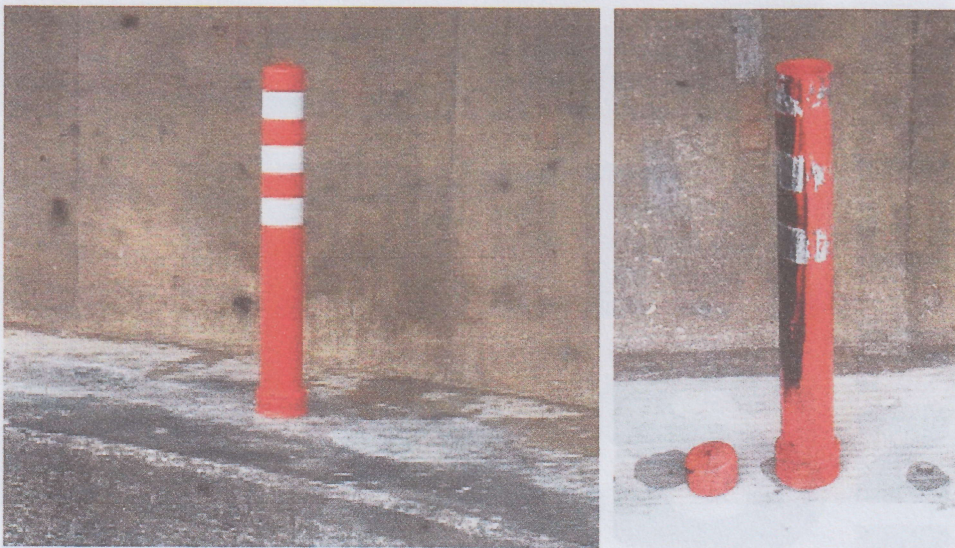
Photo 8 and 9: Photograph before and after.
The top of pole cone without extrusion pipe was broken at 140 impacts.

| Sample: Pole Cone NS Type | Durability of Impacts | Speed Recorded (km/hour)* | Portion of tested sample | | | Observation / Remark |
|---|---|---|---|---|---|--|
| Without extrusion pipe | 1000 | 69.7 km/hour (Average) | OK | OK | 140 Impact (dislodged)** | No dislodged and damaged after being subjected of Resistance to Impact test. |
